PROPOSAL PLAN
2 LOT SUBDIVISION
BOUNDARY ADJUSTMENT

3 GEE ST
 SOUTH LAUNCESTON TAS 7249

**ENVIRONMENTAL SITE ASSESSMENT
3 GEE STREET, SOUTH LAUNCESTON**

Document Reference: TG16024/1 - 02report

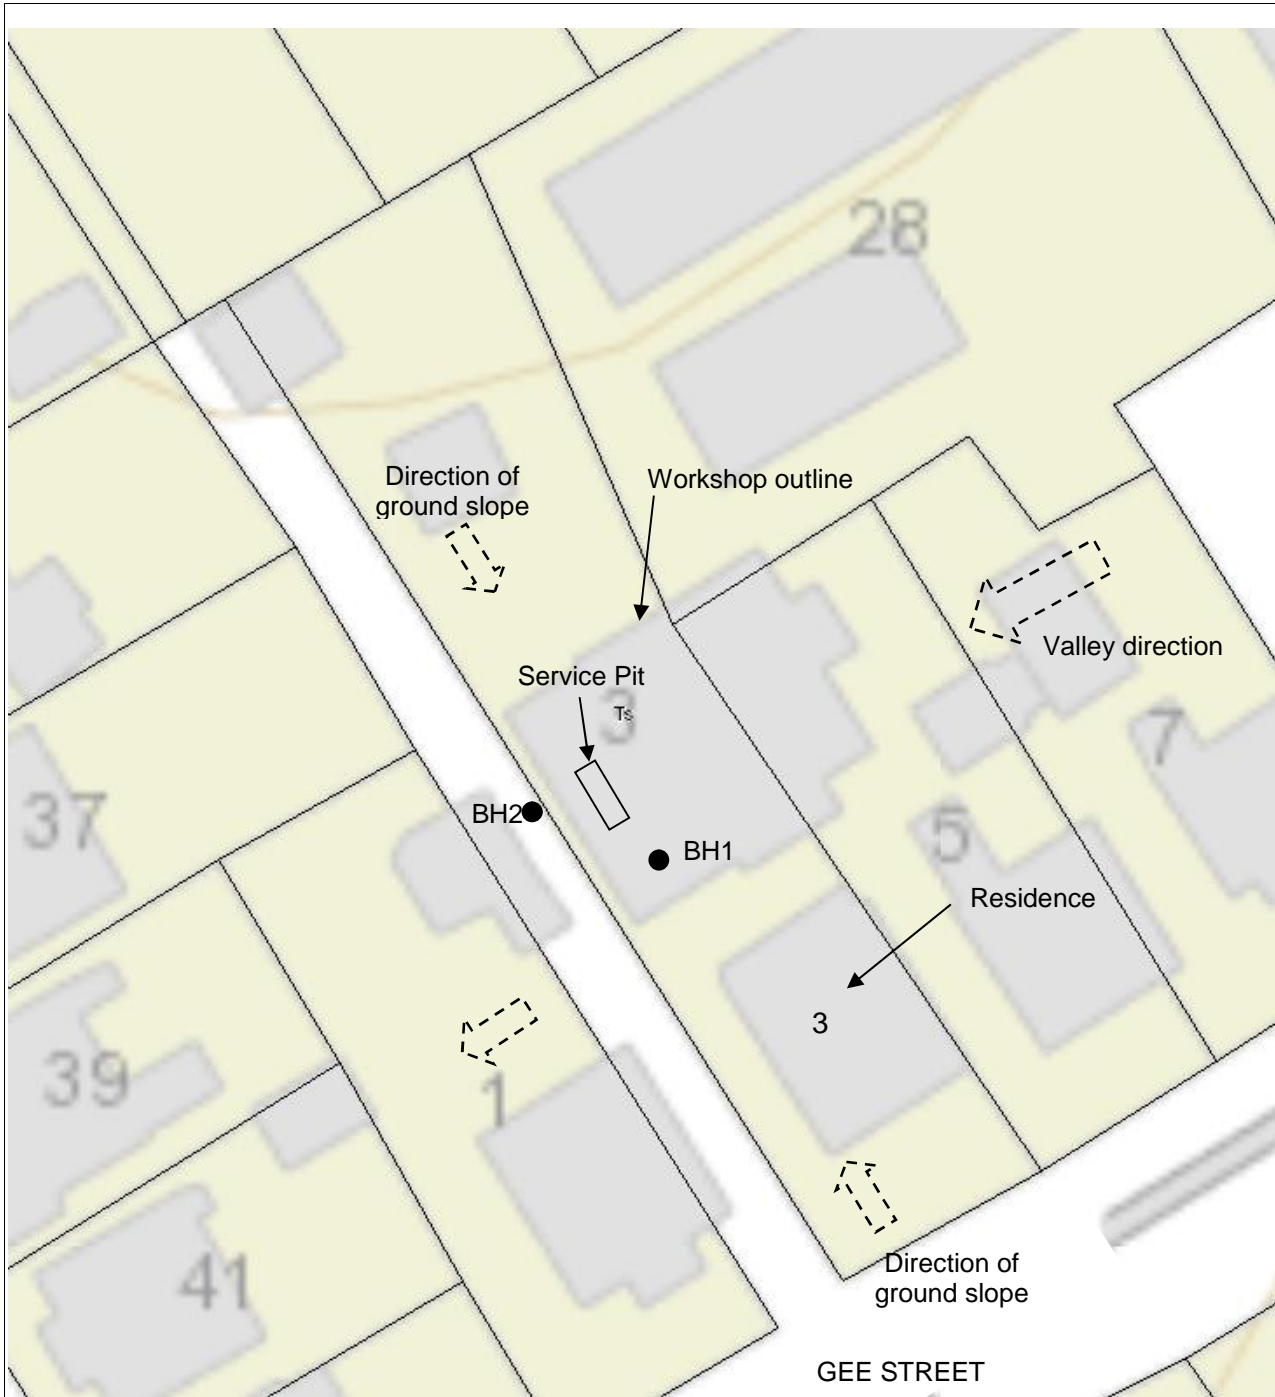
drawn	AC		client:	Angus Piercey		
approved	WG		project:	Environmental Site Assessment 3 Gee Street, Launceston		
date	24/03/2016		title:	Site Layout and Borehole Locations		
scale	NTS		project no:	TG16024/1 – 02report	figure no:	FIGURE 2
original size	A4

- BH1 to 3m depth south of the pit inside the workshop, and
- BH2 to 3m depth west (and downhill) of the pit.

The locations of the boreholes is shown in Figure 2 and engineering borehole logs are presented in Appendix B.
