**PLANNING EXHIBITED DOCUMENTS**  
 Ref. No: DA 0618/2015  
 Date advertised: 13/08/2016  
 Planning Administration

# PROPOSED UNITS

## SHEET INDEX

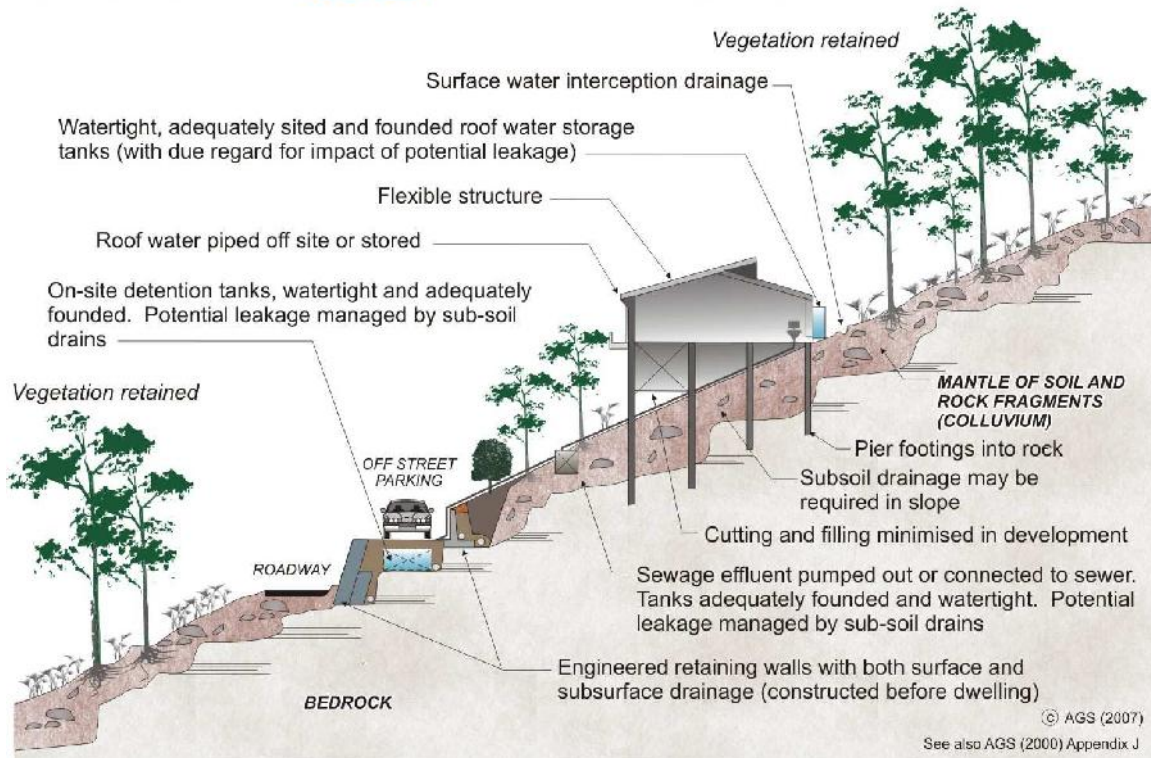
### EXAMPLES OF GOOD HILLSIDE CONSTRUCTION PRACTICE

#### WHY ARE THESE PRACTICES GOOD?

**Roadways and parking areas** - are paved and incorporate kerbs which prevent water discharging straight into the hillside (GeoGuide LR5).

Sensible development practices are required when building on hillsides, particularly if the hillside has more than a low risk of instability (GeoGuide LR7). Only building techniques intended to maintain, or reduce, the overall level of landslide risk should be considered. Examples of good hillside construction practice are illustrated below.

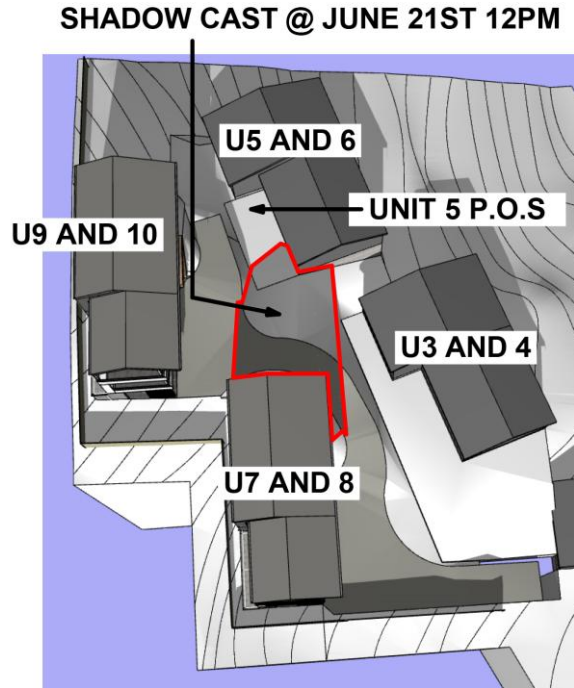
The proposed Units 7 and 8 will have a minimal impact on the level of sunlight required for existing Units 5 and 6. On the Winter Solstice at 12pm the shadow cast from Units 7 and 8 will not penetrate into any habitable room of Units 5 and 6. The private open space for Units 5 will be partially obstructed but still receive more than 3 hours of sunlight to over 50% of the private open space on the Winter Solstice. Refer to image below highlighting the shadow cast at 12pm on the 21st of June.
