# Footpath Reseal Guidelines

The objective of this guideline is to provide a clear and consistent approach to resealing the footpath and property accesses in CoL municipality.

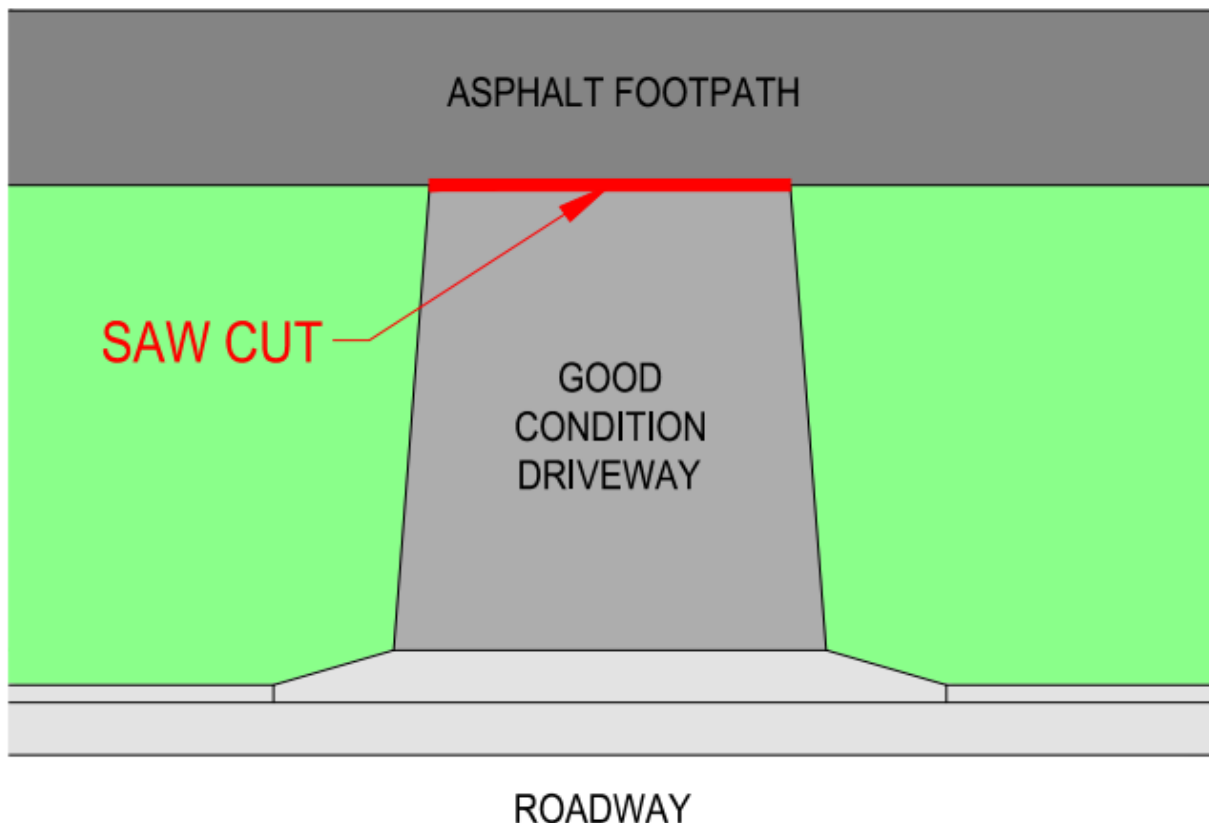
## Asphalt Driveway - Good Condition

**Treatment:** Council will reseal the footpath regardless of the driveway condition.

If the footpath is located adjacent to the back of kerb, the same treatment is to be used.

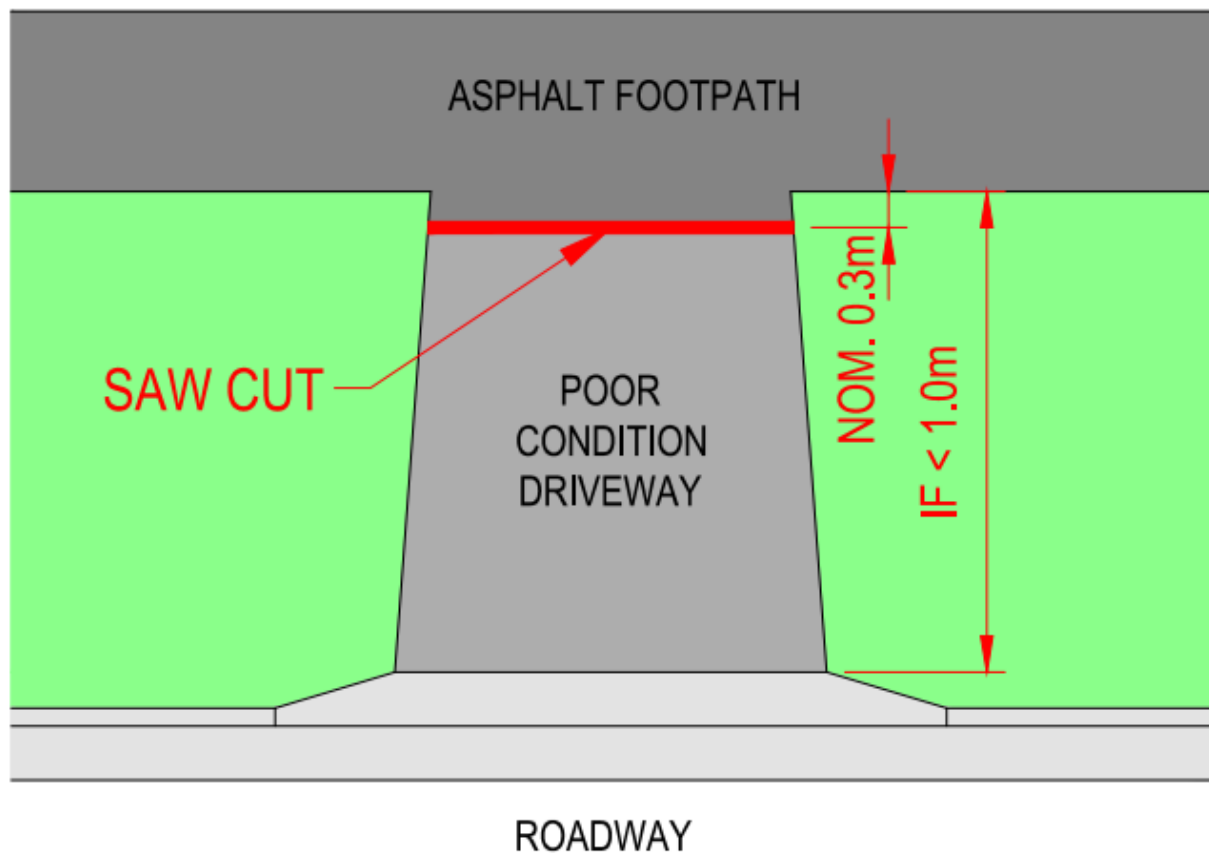
## Asphalt Driveway - Poor Condition

**Treatment 1:** When the driveway is in poor condition, the driveway is to be saw cut nominally 0.3m from the line of the footpath and the new asphalt extended to the sawcut line. The 0.3m saw cut offset is to minimise asphalt fretting extending into the new footpath.

**Treatment 2:** If the distance from the back of the crossing to the footpath is less than 1.0m, this area is to be stripped and resealed. (The saw cut is therefore not required)

If the distance from the back of the crossing to the footpath is greater than 1.0m, treatment 1 is to be used.

If the footpath is located adjacent to the back of kerb, Treatment 1 is to be used.

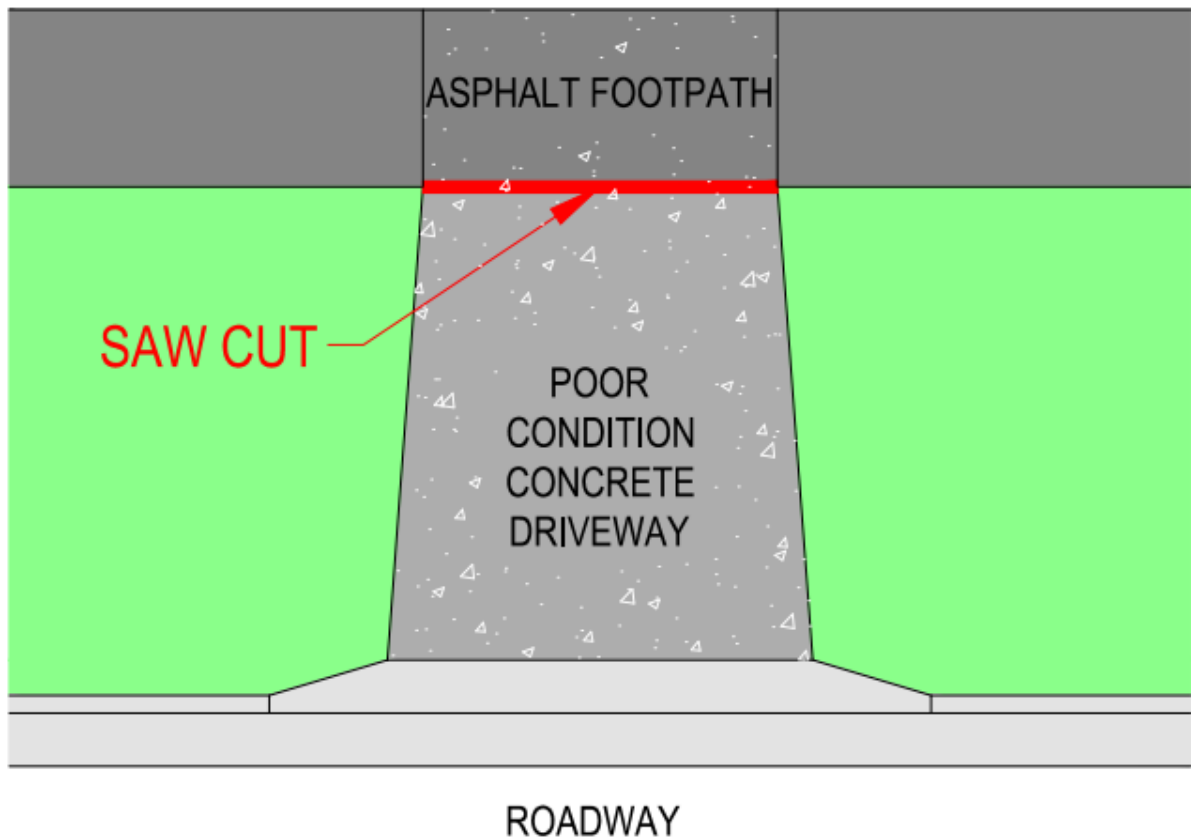
## Concrete Driveway - Poor Condition / Asphalt Footpath

**Treatment:** When the concrete driveway is in poor condition, it is to be saw cut on the footpath alignment and replaced with a new asphalt footpath.

If the footpath is located adjacent to the back of kerb, this same assessment is to be used

Note: The assessment of the concrete driveway is limited to the area shared as footpath and driveway. The concrete shared area will only be replaced if a safety issue is identified with the condition of the concrete.

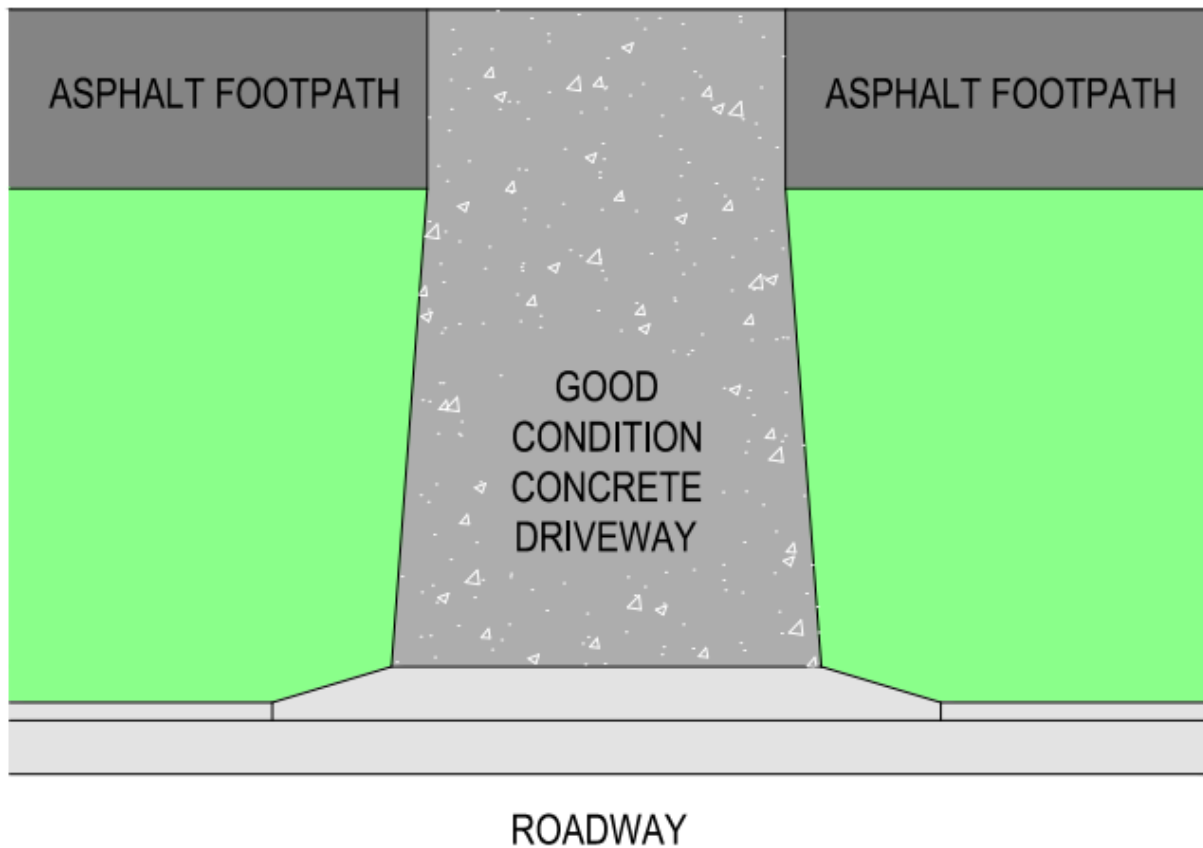
## Concrete Driveway - Good Condition / Asphalt Footpath

**Treatment:** when the shared section of the concrete driveway is in good condition, reseal the footpath up to either side of the driveway ensuring the concrete driveway does not get damaged.

If the footpath is located adjacent to the back of kerb, the same assessment is to be used.
